# Expandable Container House Structural Safety Inspection and Appraisal Report

<Report Number: JYJD-2024-0176>

**Project name:** Expandable Container House

**Project address:** No. 68 Shunda East Road, Fucheng  
Development Zone, Fucheng County, Hengshui City,  
Hebei Province

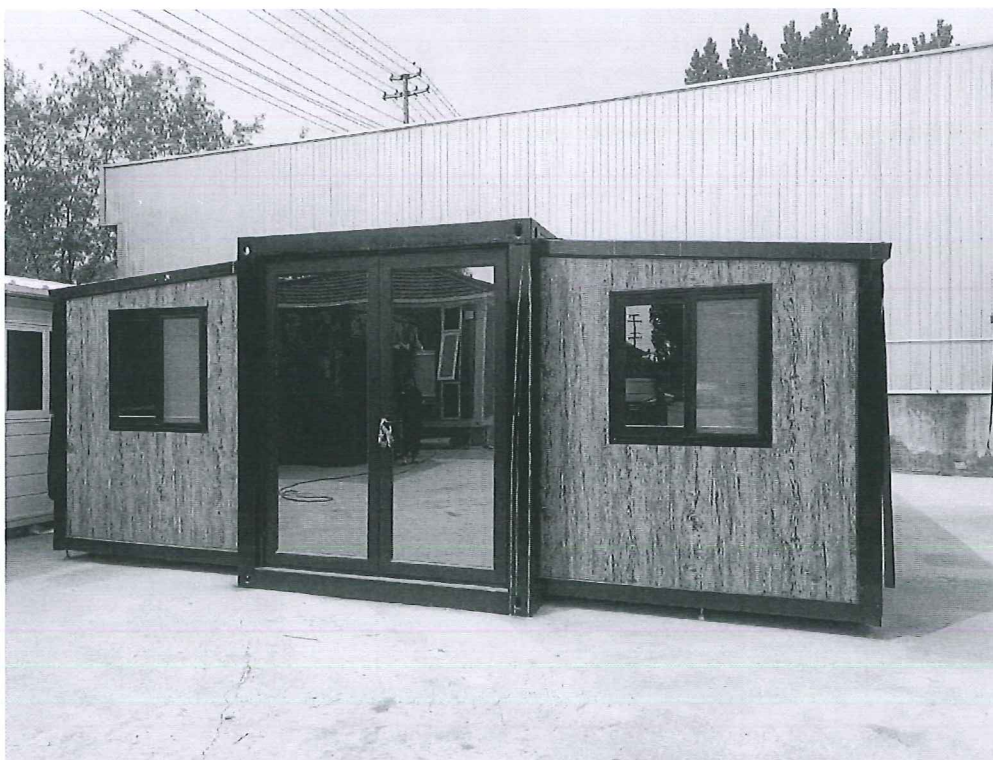
2. The main appearance quality of the key components of the steel plate house was inspected on-site, revealing no significant damage or deformations.

Exterior of the Steel Plate House

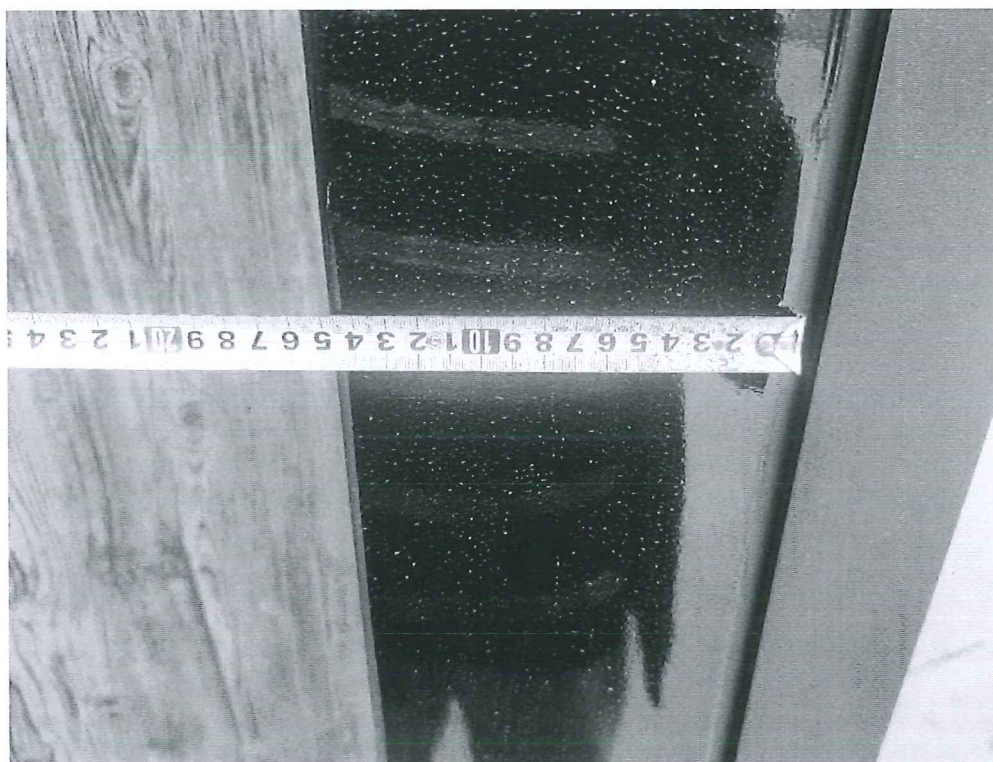
Dimension Inspection of Steel Components in the Steel Plate House

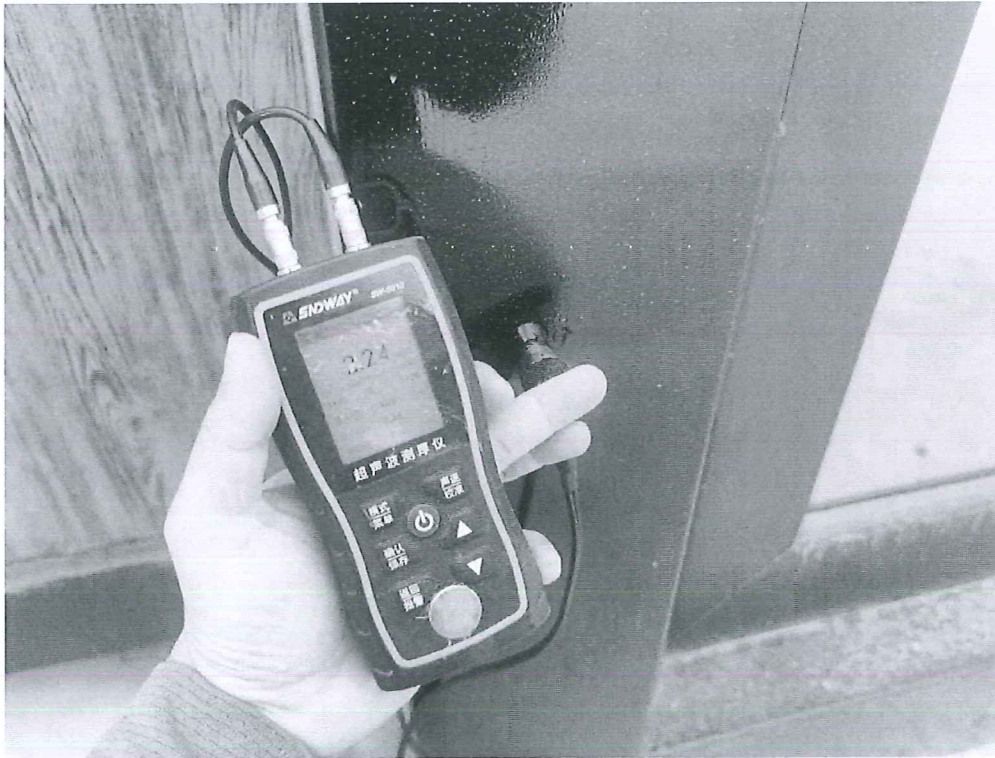
Thickness Inspection of Steel Components in the Steel Plate House

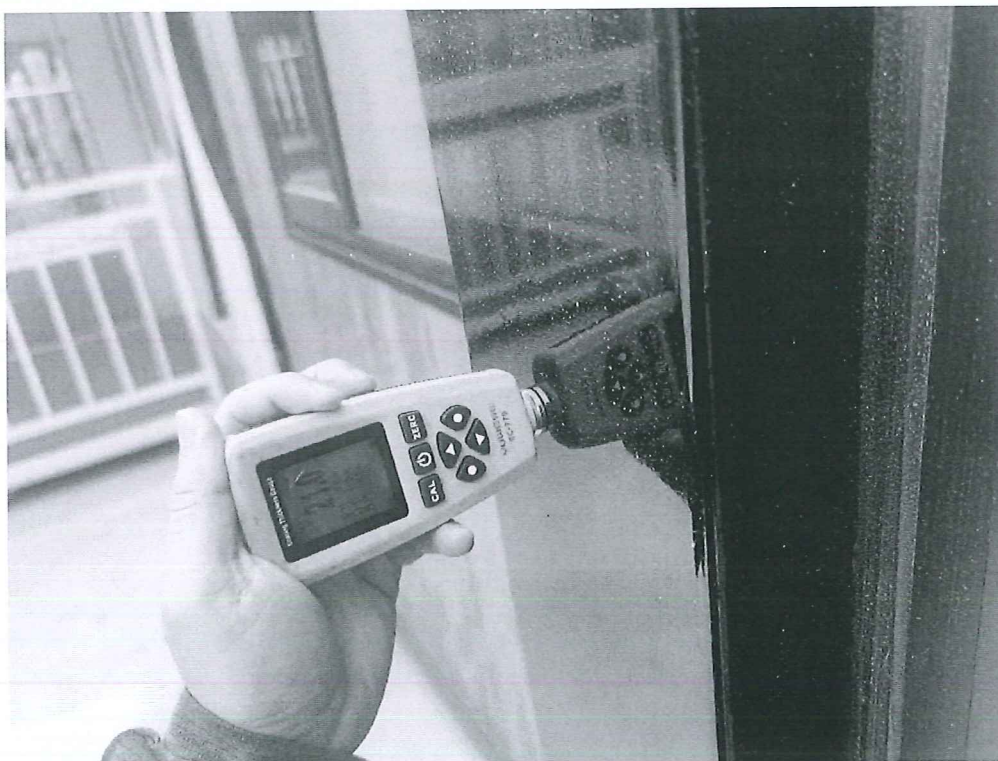
Coating Inspection of Steel Components in Steel Plate House

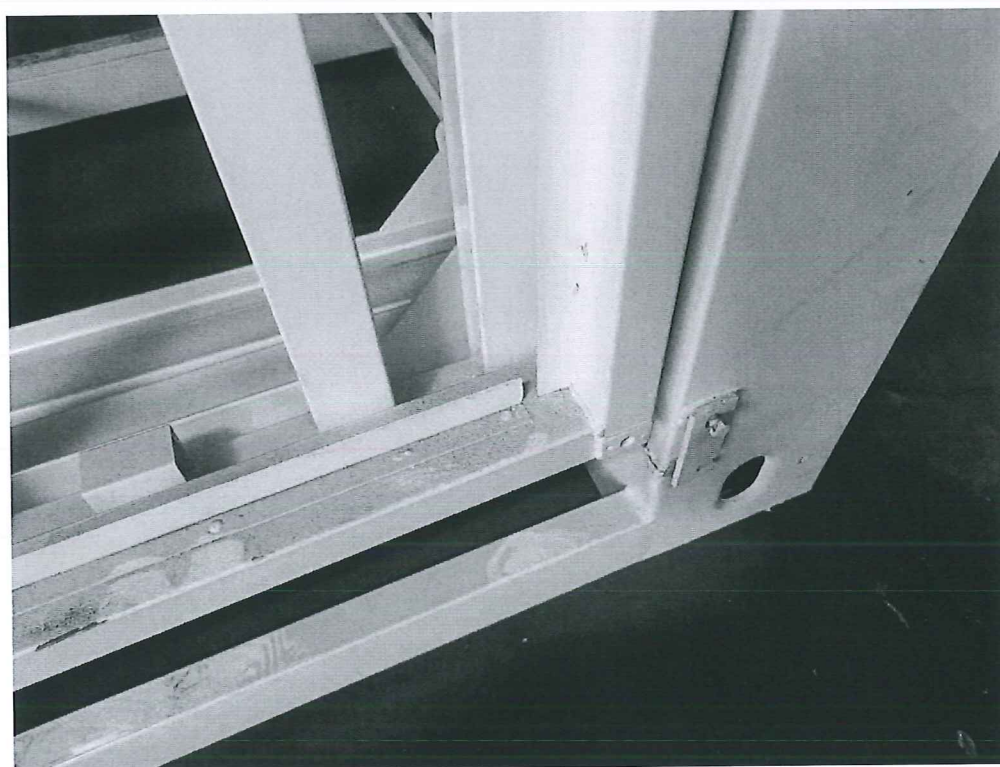
1. During on-site inspection, it was observed that the main load-bearing steel frame structure components of the steel plate house are bolt-connected between nodes and foundations, with the connections showing no abnormalities. The nodes between steel frame structural components are connected through welding and bolt connections, with the connections being generally in good condition. Weld seams exhibit a satisfactory appearance, without visible cracks, slag inclusion, undercut, or other quality defects. The quality of the sampled weld seams largely complies with the quality requirements outlined in the *Code for Acceptance of Construction Quality of Steel Structures* (GB50205-2020).

Steel Plate House Owner Bearing Support Member Node Inspection
